## STRATA MOVEMENT ENCOUNTERED DURING SHAFT-SINKING AT 17a SHAFT, CROWN MINES, LIMITED.

W. REID,

*Manager, Southern Section, Crown Mines, Ltd.*

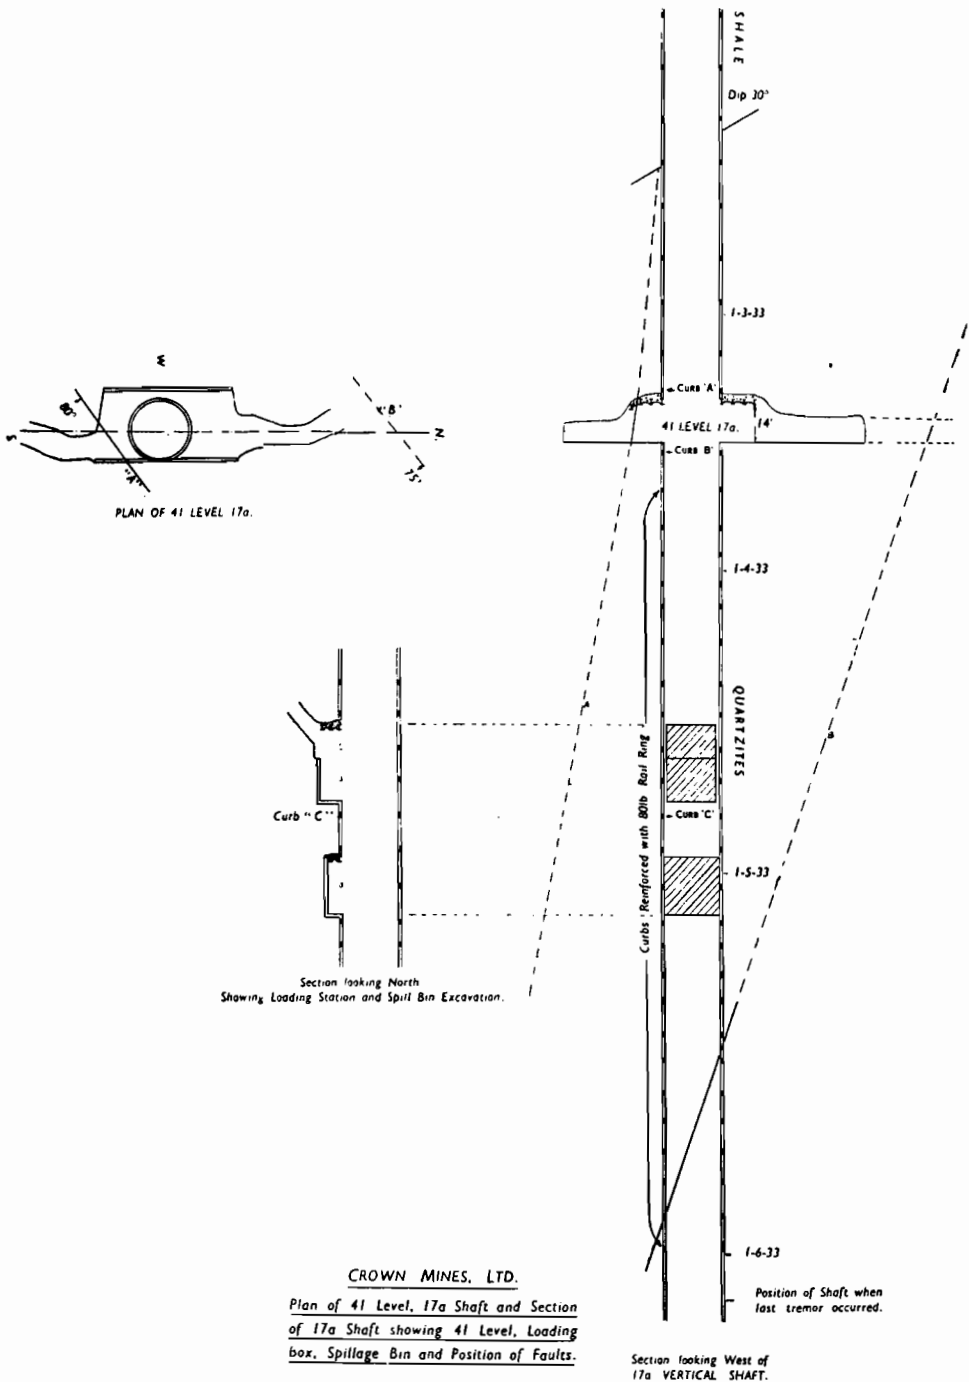
FIG. 29.

The first "tremor" occurred when the excavation for 41 Station (at a depth of 6,383 ft. below the surface) was nearly completed, and "tremors" were of frequent occurrence until the shaft was 310 ft. below 41 Station (see Fig. 29) over a period of nearly three months.

It will be seen from the plan of 41 Station and the section (Fig. 29) that the shaft was being sunk between two faults. The method employed to excavate and support stations was as follows:—Curb A (Fig. 29) was put in at a measured distance to suit the hanging of the station, after walling up to the curb above, the shaft was sunk to a few feet below Curb B and walling brought up to the footwall of 41 Station. The station excavation north and south was then proceeded with to a height of 10 ft., and 18 in. brick side walls carried to a height of 8 ft., and hanging to the required height was then blasted down, the side walls built up, steel girders placed in position and concrete filled in.

When the first lift of 41 Station had been completed, with side walls built to a height of 8 ft. and the further excavation to the full height almost completed, the first "earth tremor" occurred and was felt on the bank and engine room on the 24th Level. There had been quite a movement at Fault A, Curb A was broken on the south and the steel former buckled, the brickwork was damaged on the south for about 6 ft. of the circle to a height of 50 ft. above Curb A, the 9 in. bricks were cracked at about 4 in. from the face but still intact. As Curb A was badly broken on the south, the danger was that it might give way and let the brickwork down. This curb was supported by placing one of the Station I beams (18 in. by 6 in. by 27 ft. long) on the side walls already built and by three 3½ in. single jack bars on top of the I beam to the underside of the curb, with two similar single jack bars under the I beam to the footwall. The side walls were then built to the required height, the roof girders placed in position and the concrete filled in. On the south the concrete was reinforced with 40 lb. arch rails. The damaged brickwork above Curb A was taken out and rebuilt.

When the shaft was cleaned out after the completion of the station it was found that Curb B and the brickwork for about 5 ft. of the circle on the north had been kicked up about 1 ft.; this was taken out and rebuilt. About ten days later when the shaft bottom was about 60 ft. below 41 Station another severe "tremor" was felt, which broke Curb B and kicked up the brickwork about 1 ft. for about 5 ft. of the circle on the west, but did no damage to the side walls of the station. This portion was also taken out and rebuilt.

When the Loading Box Station (Fig. 29) had been completed and walled, a severe "tremor" was felt which broke Curb C and kicked up the brickwork on the station about 1 ft. and cracked the side wall from floor to roof, but otherwise did no damage to the shaft walling.

The concrete curbs from 41 Station to where Fault B intersected the south side of the shaft were reinforced with an 80-lb. rail ring.
