**REGUIDING No. 6 AND No. 7 COMPARTMENTS OF No. 5
SHAFT, CROWN MINES, LIMITED, WITH 30 FT.
STEEL RUNNERS.**

D. MACNIVEN,

Acting Manager, Eastern Section (No. 5 Shaft), Crown Mines, Ltd.

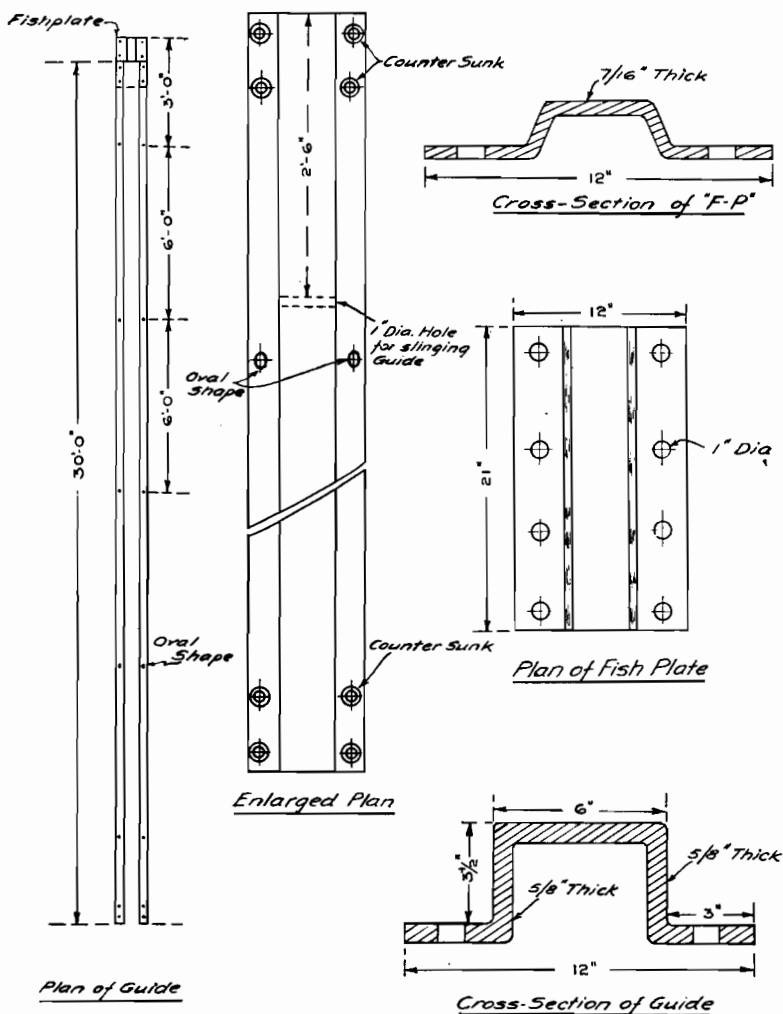
FIG. 26.

At the beginning of 1933 it became clear that the old steel guides, which had seen about 12 years' service, would have to be replaced from the collar of the shaft to 19 station, 3,240 ft. in all.

Preparatory Shaft Work.—The number of guides to be replaced was 216 in each compartment, i.e., 108 30 ft. steel runners (Fig. 26) on each side of both compartments, making a total of 432.
