## NOTES ON THE OPENING-UP AND RETIMBERING OF No. 3 VERTICAL SHAFT, GELDENHUIS DEEP, LIMITED.

T. McALPINE,

*Manager, Geldenhuis Deep, Ltd.*

— Geldenhuis Deep L<sup>rd</sup> —  
 — Plan Showing Retimbering N<sup>o</sup> 3 Shaft —  
 — after pressure burst 47·4·1932. —

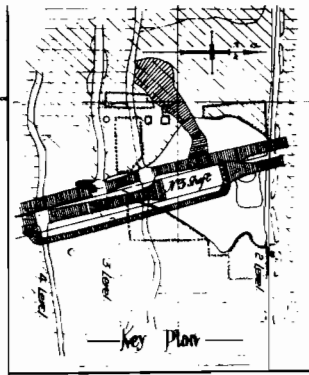
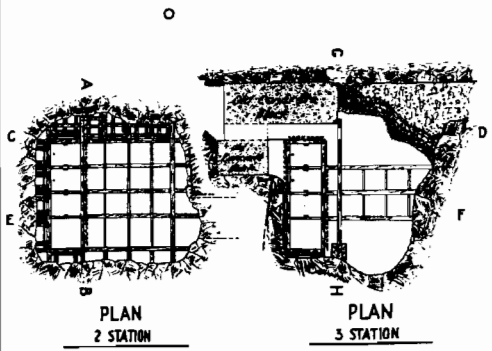
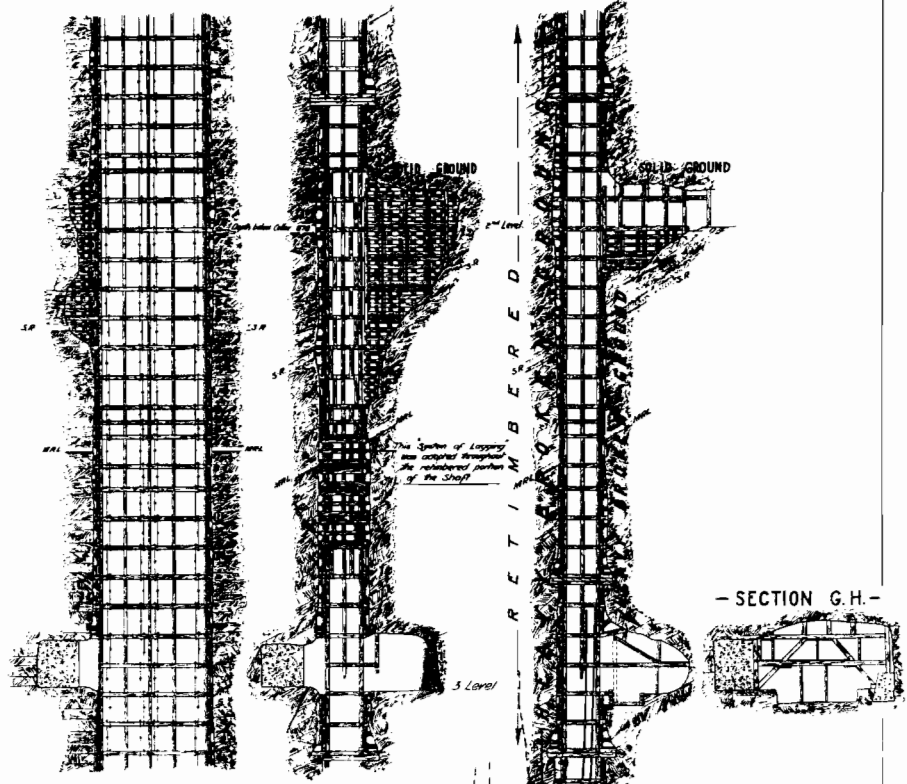
Shortly afterwards it was found that a portion of No. 3 shaft from above No. 2 Station down to above the bend, a distance of 135 ft., was wrecked. The shaft intersects the South Reef 23 ft. below No. 2 Station. Above No. 2 Station the north wall of the shaft was sound, but the south wall was badly broken. A sett of bearers was put in 16 ft. above the station and the re-opening of the shaft commenced.

When the floor of No. 2 Station was reached, it was found that the north and south walls had crushed tight together and it was ascertained later that this condition continued for a depth of 60 ft. Owing to the floor of No. 2 Station having caved the trouble that faced us was to find some means of supporting the north side of our shaft setts, in order to support the south wall of the shaft, which was still heavily broken.

Fortunately the hanging wall of No. 2 Station was sound and it was decided to hang square timber setts through the station and as far down below it as the caved floor of the station extended. The square setting had to be carried down a sett in advance of the shaft timbers. The ground was so badly broken on the south side that we could only clean out for half a sett of shaft timber at a time, this being put in and securely blocked before the other two compartments were cleaned out and the other half sett completed. This system was carried on successfully right through the closed portion of the shaft.

The different sizes of timber used were as follows:—Wall plates, end plates and corner studdles 8 in. by 8 in., dividers and inside studdles 8 in. by 6 in. The setts were hung at 6 ft. centres, except in a few instances where the state of the rock would not allow this distance.

Owing to the heavy and broken condition of the ground that was exposed in the opening of the shaft, it was anticipated that the new timber might be subject to heavy pressure and trouble might be encountered in keeping the shaft timbers in a truly vertical position. It was therefore decided that the side and end walls of the shaft should be opened up enough to give 12 in. minimum clearance behind the timber and some system of lagging adopted that could be released in the event of excessive pressure being shown on the timbers.

The type of lagging to support the ground between the setts was as follows:—6 in. by 8 in. timber checked at the end to the depth of  $\frac{3}{4}$  in. was cut and fitted vertically between and at the back of the setts, two on the north and the south side of each compartment and two on each end

piece. Behind the 6 in. by 8 in. lagging 9 in. by 3 in. deals were fixed horizontally 9 in. apart, and light blocking fixed where necessary to support the broken sides between the setts. The wider portions of the shaft, where the blocking was rather long, were further secured by utilizing the old timber recovered from the shaft and building it in the form of chocks between the setts and the walls of the shaft. Winding was resumed on 7th May, the total time of the stoppage being 20 days.
