Extraction of 5 West Sub Vertical Shaft Pillar - the Final Stages

A W STILLWELL
West Driefontein Mine

SYNOPSIS

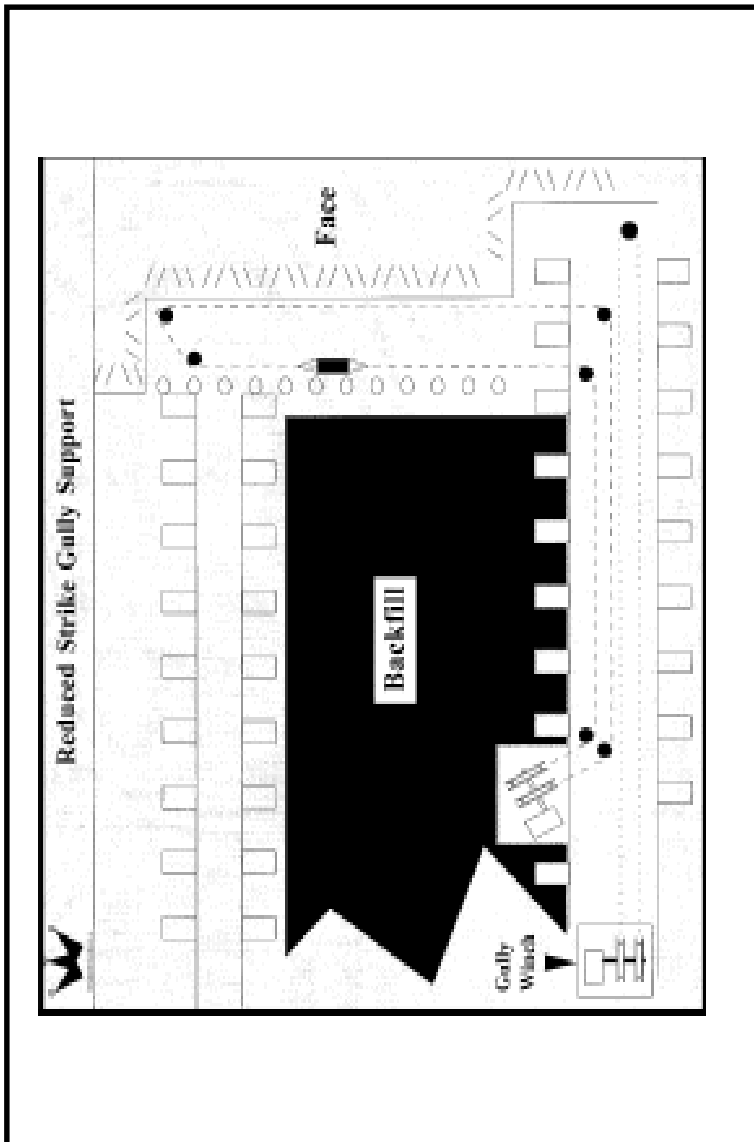
Figure 11

Five years of mining in the pillar using the stoping methods described above, indicated that the damage caused by seismicity was more severe in the gullies than in the stope faces themselves. This led to a decision to extend the backfill right down to the gully shoulders in an attempt to reduce the span over which differential support loading took place. This practice was then followed for a further four years, and although a vast improvement on what previously occurred, did not appear to have entirely solved the problem (Figure 11).

In 1993, it was decided to do away with solid timber packs on gully ledges and to replace them with specially engineered light weight concrete packs, which would provide roughly the same support characteristics as the backfill. This change resulted in the general hangingwall conditions becoming much more stable, and it was noticed that the

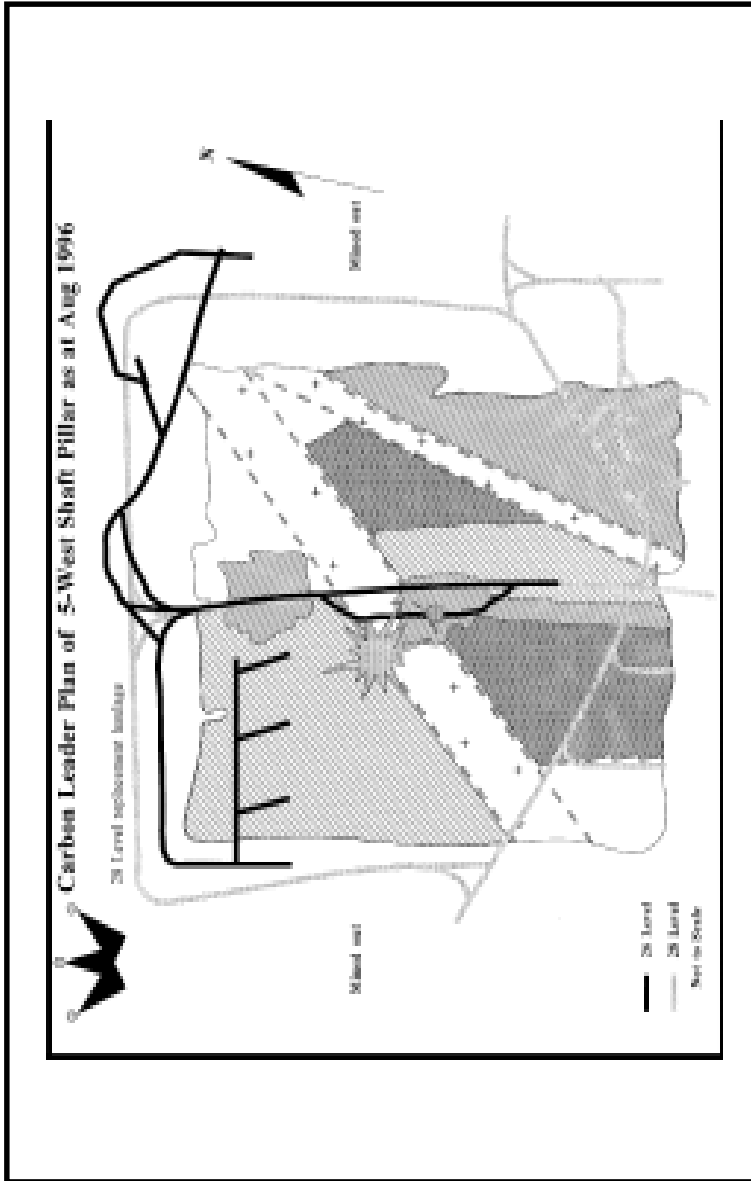
At 14h20 on Sunday 11 August 1996 a severe tremor was felt on surface, which was later that evening, determined to be a seismic event at the No 5 West Sub Vertical Shaft. The following morning, it was discovered that severe inward deformation of the shaft lining had taken place, as well as distortion of the shaft steelwork, to such an extent that the free movement of conveyances through the shaft was impeded.

The bulk of the concrete movement into the shaft was found to be in the north western sidewall rendering the western rock and man compartments unserviceable. The wire meshing and cable anchor support had moved out into the shaft by some 300mm to 500mm over an area of some 5m^2 ($\pm 3\text{m}$ in the circumferential direction by $\pm 1,5\text{m}$ in the axial plane). The damaged area was estimated to be somewhere between 3m and 5m above the 26 level station, i.e. where

the Carbon Leader intersects the shaft. The rest of the shaft lining, on the same elevation and on the north east around to the south eastern side showed only signs of minor cracks and appeared generally stable.

Steelwork damage was more severe, with three bunton sets, which under normal circumstances are aligned in the north south axis, being compressed by some 250mm causing them to bend. In addition, the vertical displacement of the concrete lining, four sets up from 26 level, had caused the stabilizer to fail and had disorientated the whole set by some 2° to 5°. Numerous guides in all compartments were bent with the curved section protruding some 300mm into the compartment. Guide damage extended for some 15m to 20m along the vertical axis of the shaft in the vicinity of 26 level reef intersection.

The seismic event, which registered 3,4 on the Richter scale was focused on the BV 74 dyke some 90m west of the shaft and 100m above the 26 level elevation. The dyke has a strike orientation NE-SW and dips at a relatively flat angle of 60° - 70° towards the north, and actually intersects the shaft on the 26 level station. Figure 14 depicts the extent of mining on the day the event took place.

After careful consideration of the damage it was decided that the shaft be abandoned because the remaining block of ground contained 15 000m², which could be accessed from the adjoining 5A Sub Vertical Shaft 1 900m away, and successfully extracted.

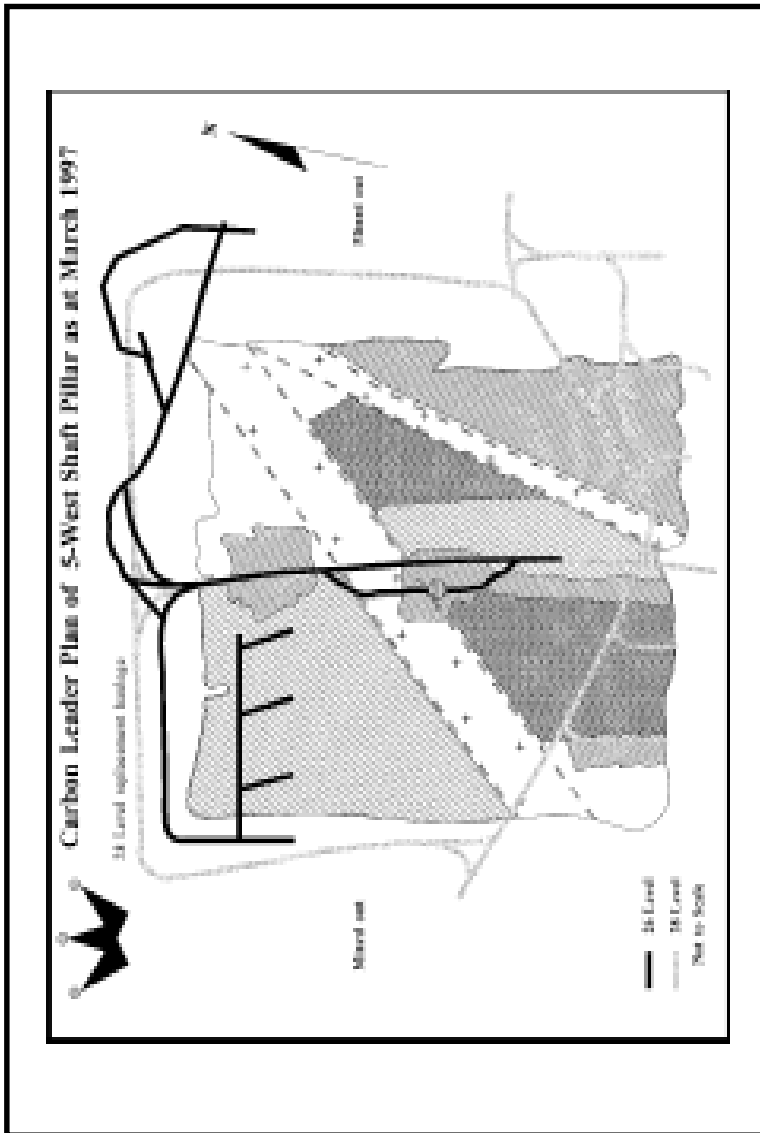
Figure 15

In total, only 4 000m² were mined during this time, when in March 1997, a seismic event was recorded in the area which caused severe falls of ground affecting a large area.

Although no serious damage was seen in the stope faces themselves, the access ways to the stope as well as most dip and strike gullies were severely affected making access to the working areas virtually impossible.

At the time only two panels were still working, due to poor face shapes that had been brought about by previous incidents of seismicity, and it was then that a decision was taken to stop mining in the pillar altogether. (Figure 15)
