# AMB Chairlift Chair Failures

Tiaan Deysel  
Resident Engineer – AMB Mining Ops

4 June 2026

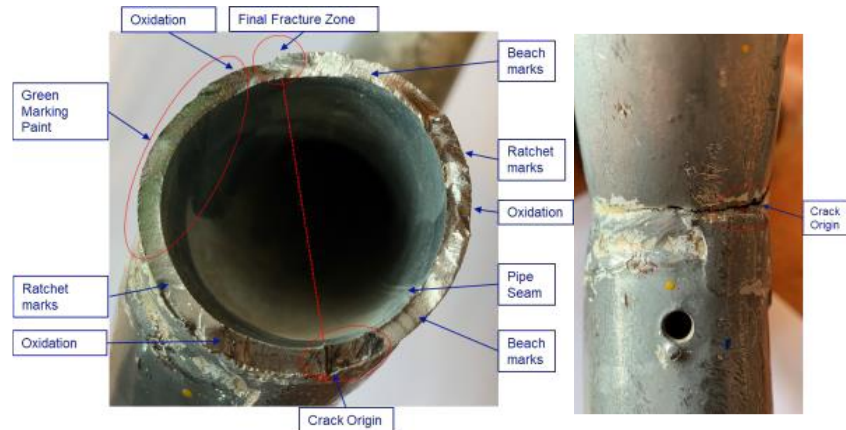
## 30W Surface Chairlift – Failure 3:

- Failure mode similar to the first two failures

NDT Date : 20 Aug 2021

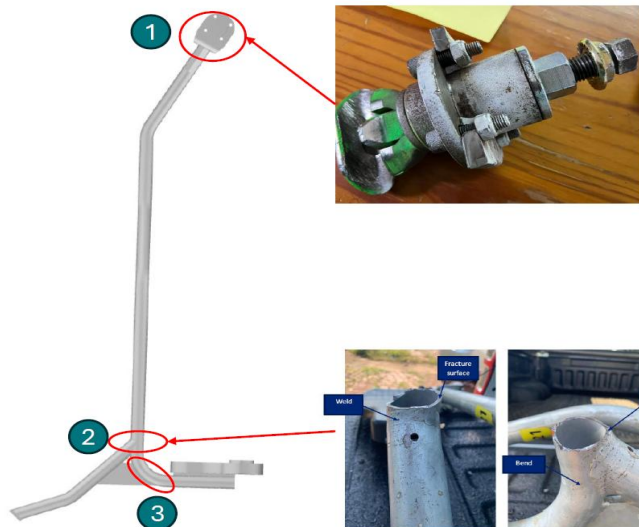
## Legacy Chair Design

- Rope grip mounting flange:**
  - inspect for cracks originating from bolt holes – crack originates at bolt hole and propagates to outer edge of flange
  - Inspect fillet welds between pipe and flange/support angle/gusset plates
- Footrest pipe weld**
  - inspect for cracks originating from weld root – critical area
  - Weld propagates from weld in a transverse direction to the pipe
- Main pipe bend towards seat**
  - Inspect area for cracks originating in high stress area – crack propagates in a transverse direction to the pipe

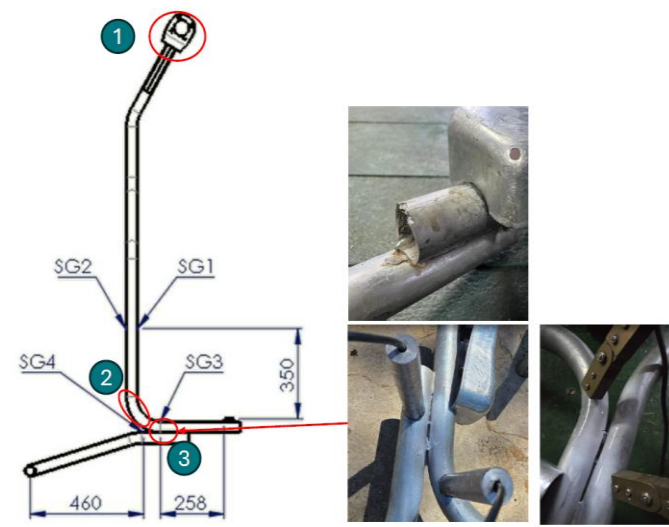
## Hybrid Chair Design V1.0

- Rope grip mounting flange:**
  - inspect for cracks originating from bolt holes – crack originates at bolt hole and propagates to outer edge of flange
  - Inspect fillet welds between pipe and flange/support angle/gusset plates
- Main pipe bend towards seat**
  - Inspect area for cracks originating in high stress area – crack propagates in a transverse direction to the pipe
- Footrest pipe weld**
  - inspect for cracks originating from weld root – critical area – **Chair must be placed on it's side to inspect effectively, inspect both sides**
  - Weld propagates from weld in a transverse direction to the pipe

ACFM or permanent magnet may be used, place across area as shown to pick up transverse crack

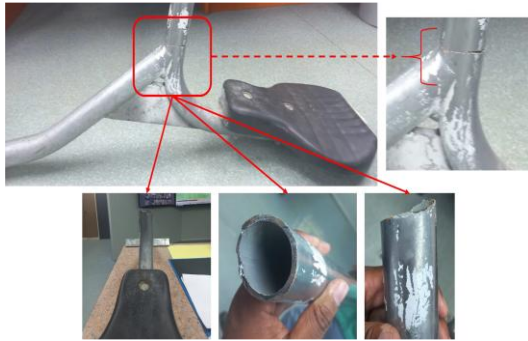
**4/15 Chairlift – Chair detaches from carrier :**

- Failure mode is similar to the initial failure.
- Immediate controls applied: NDT scheduled for the following day across remaining chairs; failure linked to legacy design.

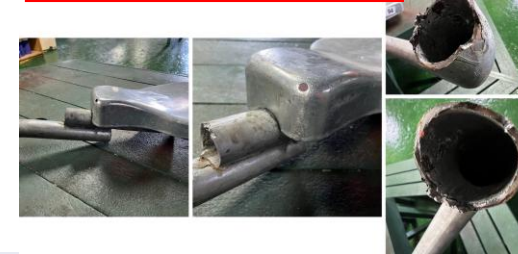
**15E – 15SI Chairlift – New-design chair seat failure at Weld:**

- New seat design to mitigate chair failure failed, 15 months in service
- NDT had been done 5 days earlier with no defects recorded,

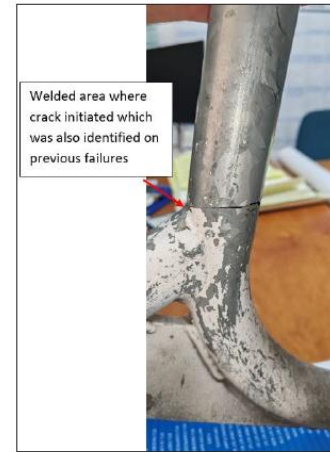
*Figure 1: Failure Zone at Tubular Frame Weld*

*Shows the welded interface where the crack initiated, consistent with previous failures on similar chair designs.*

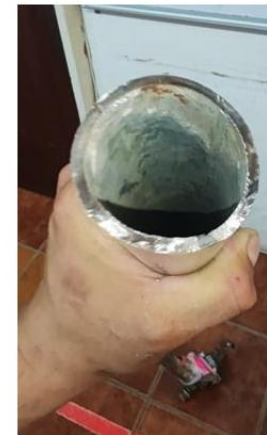
*Figure 2: Rust and Water Ingress at Crack Origin*

*Internal corrosion and rust streaking confirming long-term crack propagation and moisture penetration inside the tubular frame.*

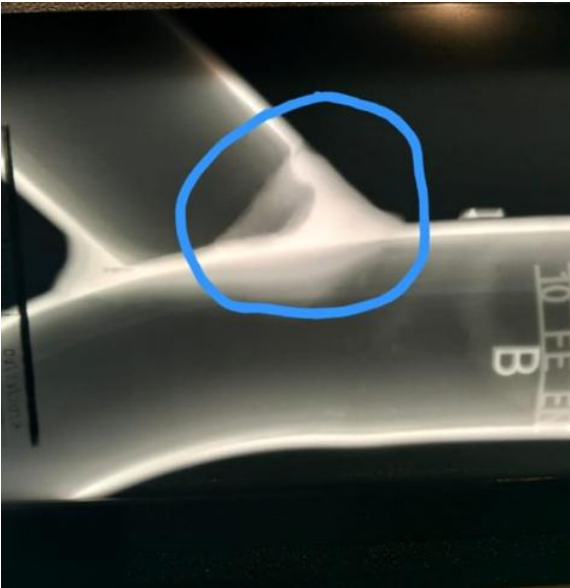
Pipe cut short – filled with welding

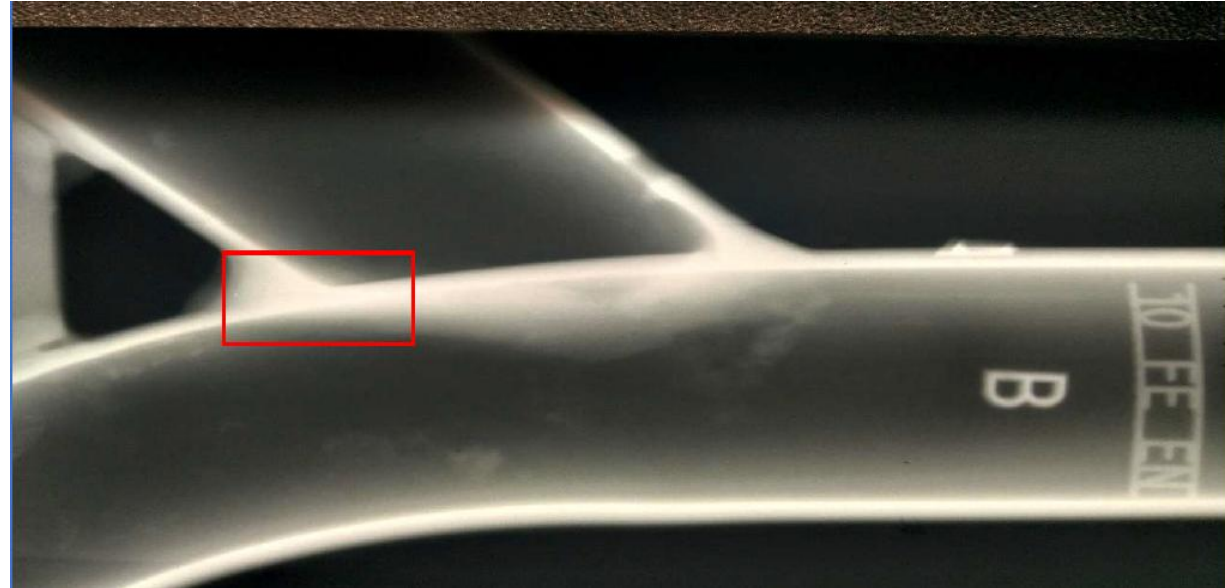
Lack of Fusion

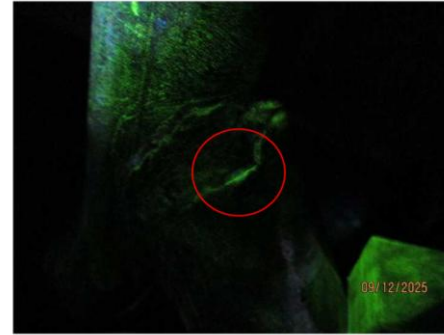
Fig 17: Chairlift No: 112  
Crack like indications noted.

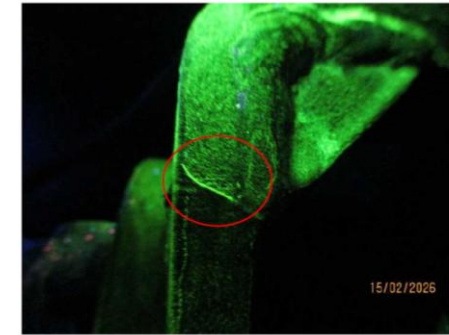
Fig 3: Chairlift No: SI/43  
Crack like indications noted.

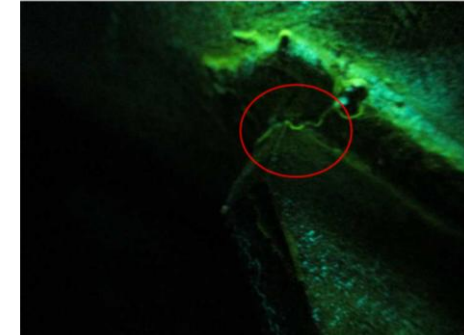
Fig 4: Chairlift No: Carrier SI/149  
Crack like indications noted.

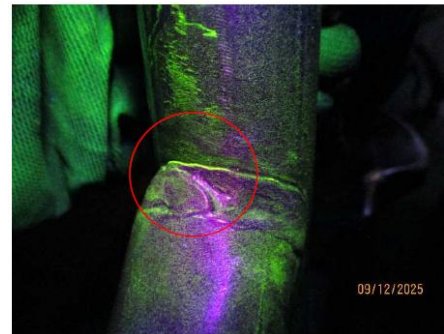
Fig 16: Chairlift No: 46  
Cold lap indications noted.

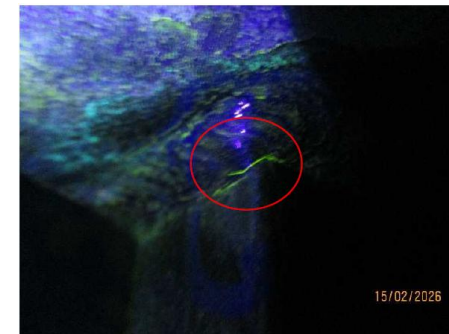
Fig 1: Chairlift No: FW/60  
Crack like indications noted.

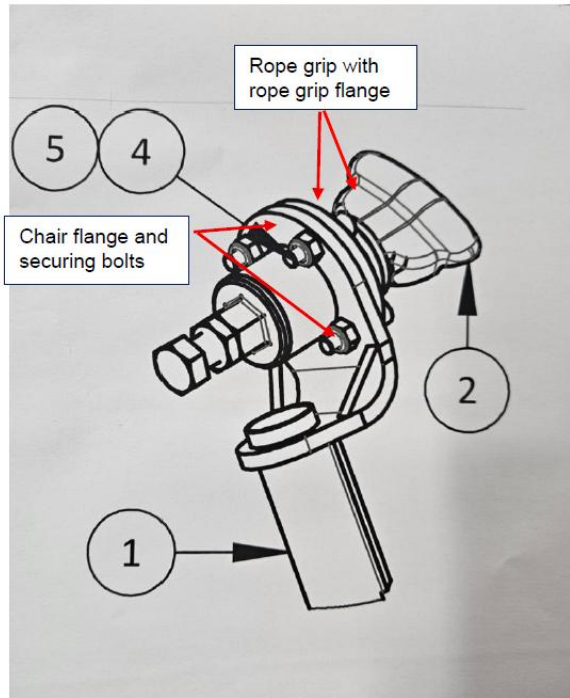
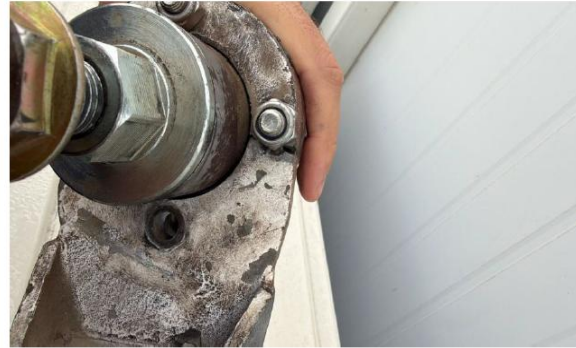
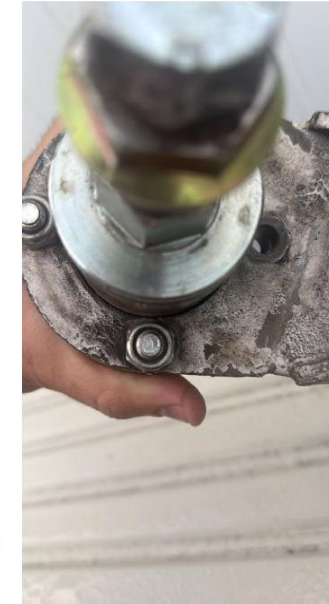
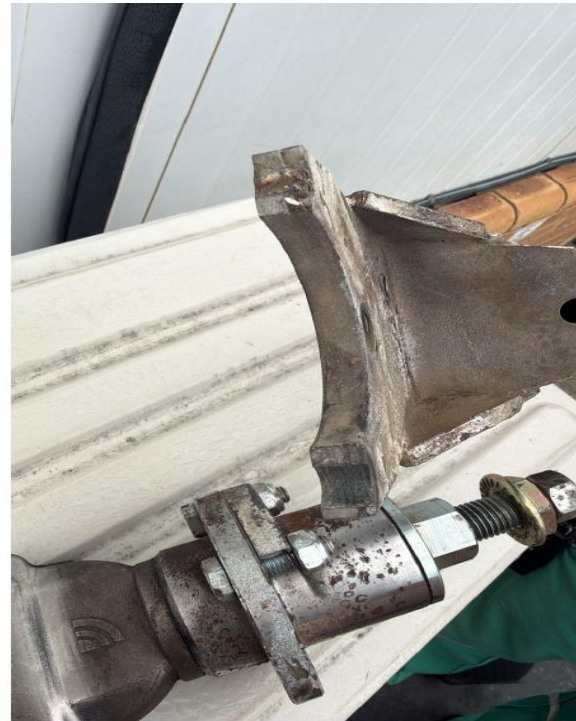
- 24 March 2026 chair failure at rope grip area
- Visual inspection on all chairs for cracks at the rope grip area – None identified
- Inspected the rope grip bolts to be tight – 5 chairs identified with some loose bolts
- Removal of the chair from the rope grip for access for proper NDT

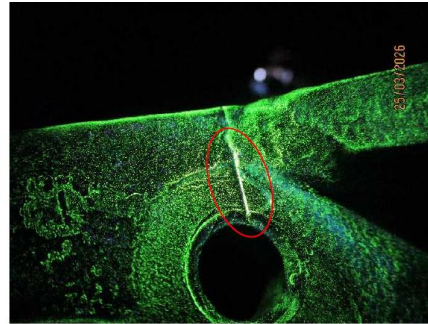
Fig 19: Chairlift No: SI/98  
Crack like indications noted.

- It is recommended that the chairlift chairs that failed the NDT inspection be removed from service.

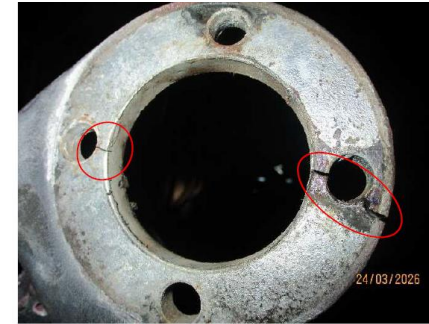
Fig 20: Chairlift No: SI/21  
Crack like indications noted.

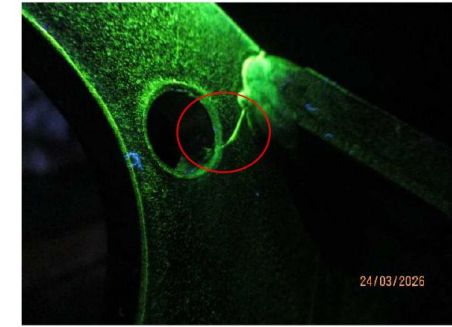
Fig 3: Chairlift No: SI/106  
Crack like indications noted.

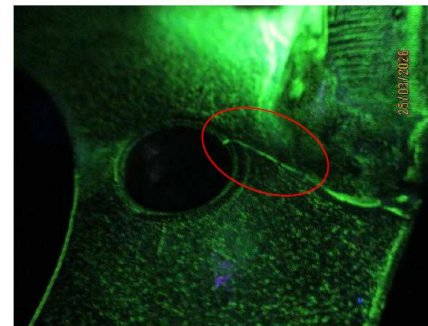
Fig 5: Chairlift No: SI/18  
Crack like indications noted.

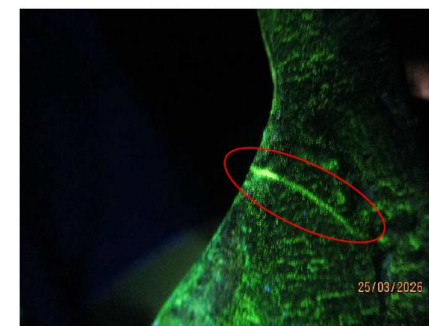
Fig 9: Stretcher Carrier No: SI/141  
Crack like indications noted.

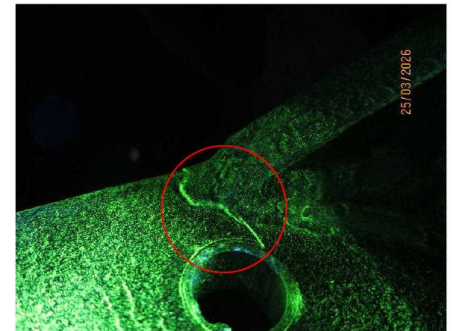
Fig 2: Chairlift No: SI/112  
Crack like indications noted.

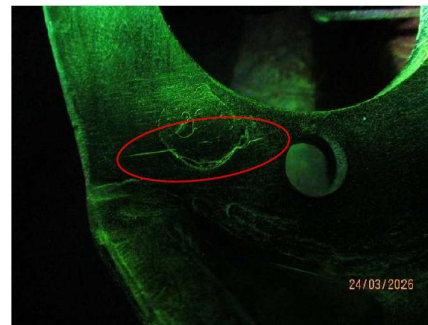
Fig 15: Chairlift No: SI/17  
Crack like indications noted.

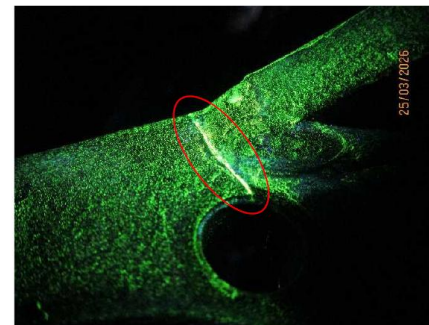
Fig 16: Chairlift No: SI/90  
Crack like indications noted.
