Review of the In-Stope Pillar Cutting Support System at Merriespruit 3 Shaft

SYNOPSIS

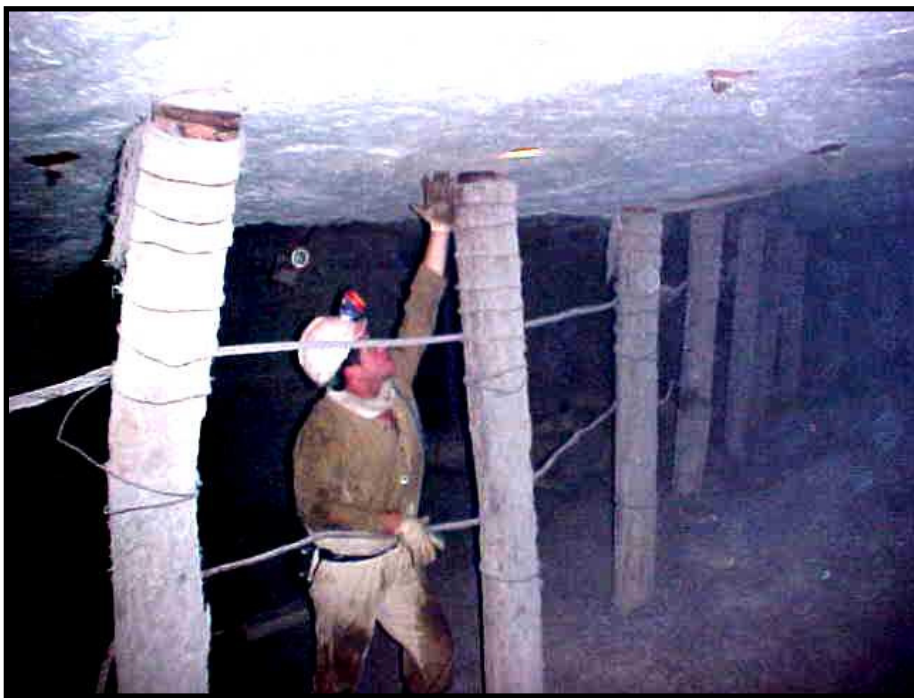
Photo 1

A line of elongate support and back area barricade ropes installed in a panel.

Support lines and grids are painted in and used with relevant ease, making use of measuring tapes and / or string. The introduction of a grid line support system greatly assisted in the support installation and the sweeping cycle. The implementation of the grid line support system assisted in the use of blasting and back area barricades as well as the reduction of support re-installed during sweeping operations (see Photo 1).

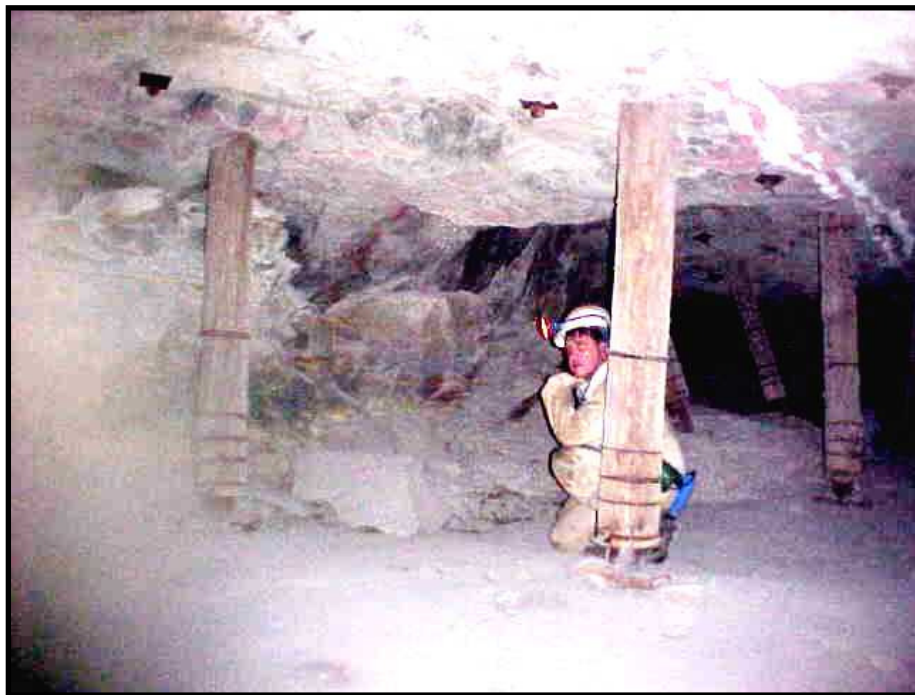
Photo 2
Scaling of the updip crush pillar

In the pillar and elongate support system panels are situated between rib pillars. As the rib pillars are cut from the panel face, the pillar has already been fractured and will crush and scale. This poses the threat of rocks scaling from gully sidewall where no siding is carried or from updip pillar rolling downdip in reefs with relatively steep dips. This threat was eliminated by installing support less than 1m from the top siding on which a plank barricade is erected to protect workers working downdip from the pillar and the cutting of sidings or pinning the gully sidewalls. In Photo 2, scaling of the updip sidewall of the pillar is clearly visible.

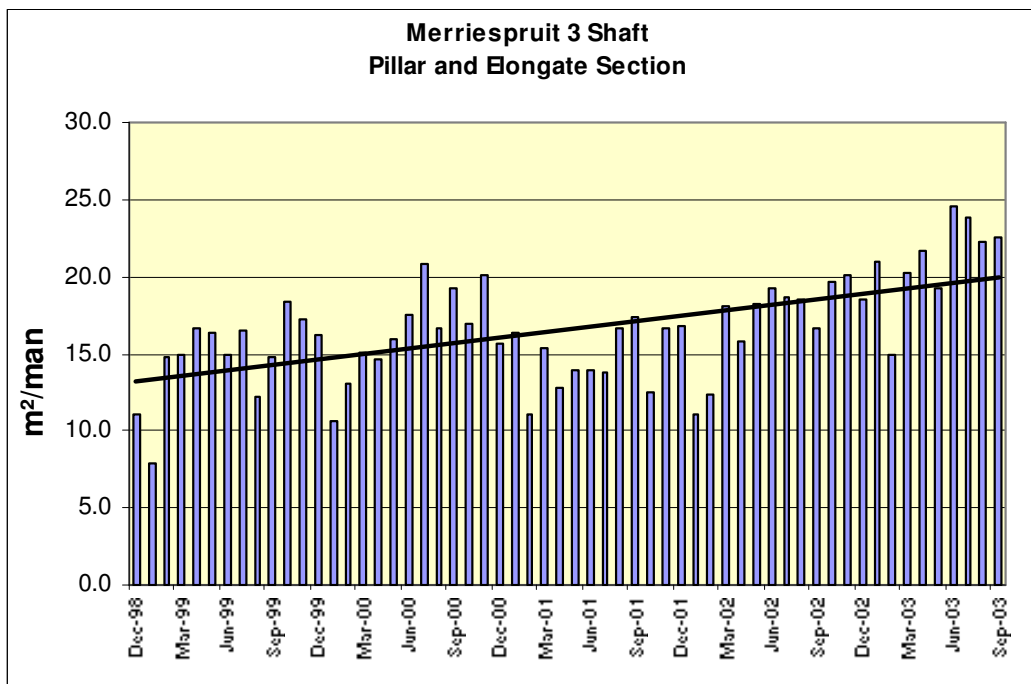
Figure 4

As the average stoving width in the section has remained at 220cm for the last 3 years, the square meters/man criterion was also used as an efficiency indicator (see Figure 4). From the graph, it is evident that the square meters/man have increased from 14 to 20, resulting in 50% increase over the last 5 years to September 2003.

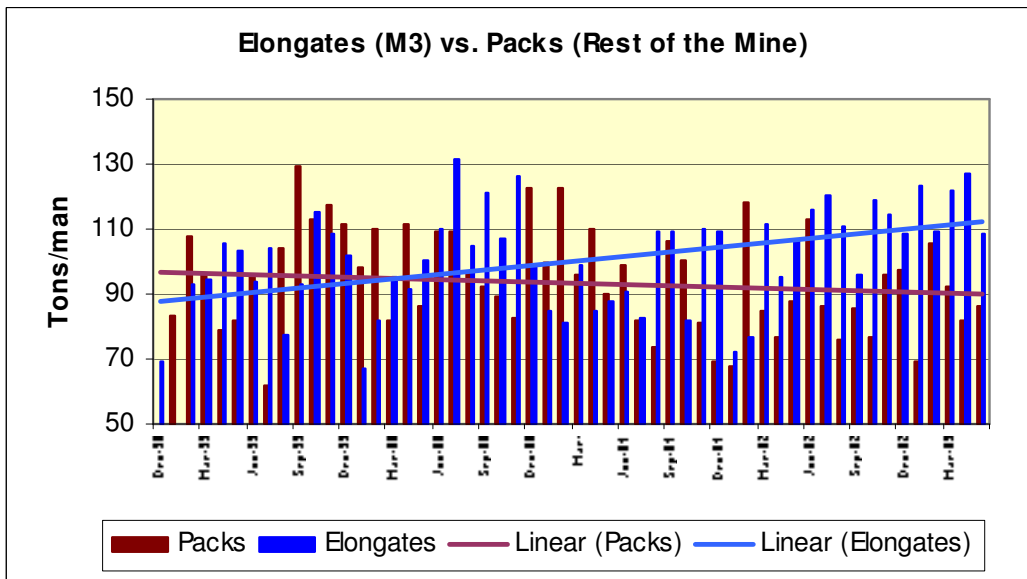
Figure 6
Efficiency trends of the different mining section measured in tons/man

When the pillar and elongate system is compared to the mining sections still mining on a pack support system, it is evident that, although during the initial period of introduction where the system seemed less efficient, it would appear that for the last 2 years the pillar and elongate support system has exceeded the efficiencies of the sections on the pack support system. Due to the large variations in stoving widths of the 2 sections, both the square meters and tons per man are used as efficiency indicators seen in Figures 5 and 6.

When comparing the two mining systems, it is evident that the higher stoping width, pillar and elongate section compared favourably with the traditional pack sections in March 2000 on tons/man as well as with the m²/man in the early months of 2001. Since then, the pillar and elongate sections have generally been more efficient.
