# AMB Chairlift Chair Failures

Tiaan Deysel  
Resident Engineer – AMB Mining Ops

4 June 2026

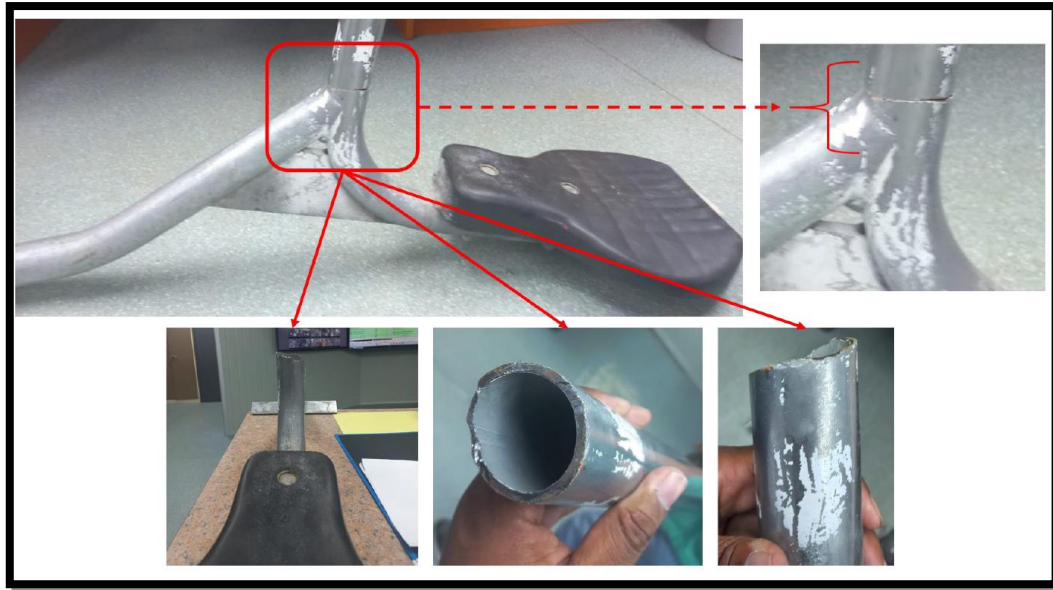
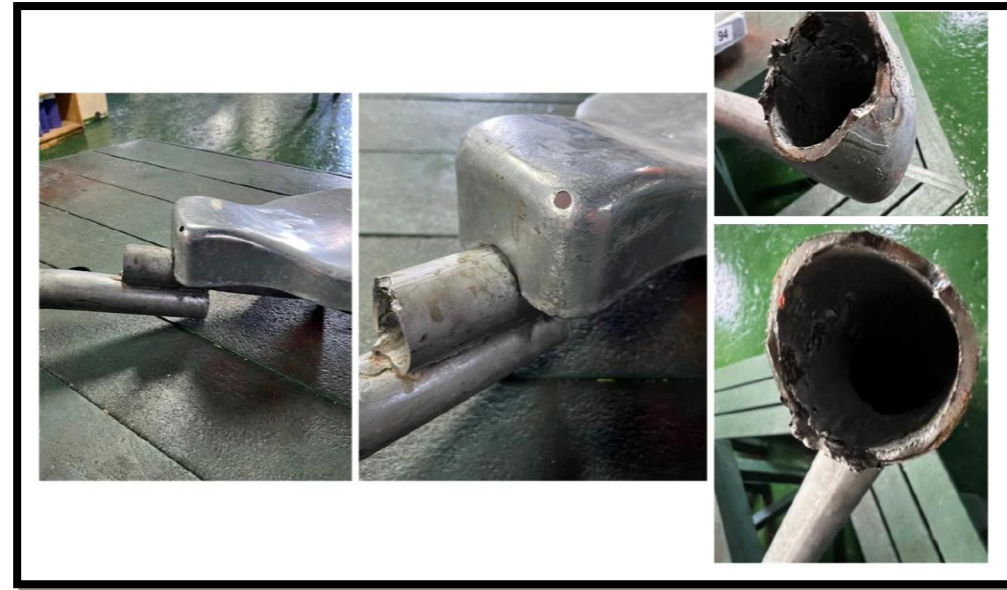
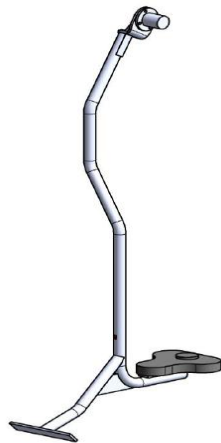
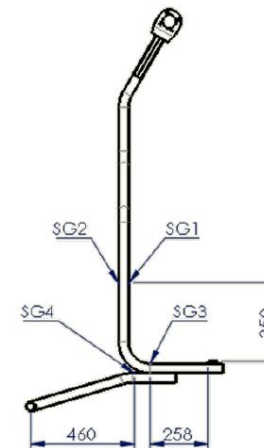
**15E – 15SI Chairlift – New-design chair seat failure at Weld:**

- New seat design to mitigate chair failure failed, 15 months in service
- NDT had been done 5 days earlier with no defects recorded,

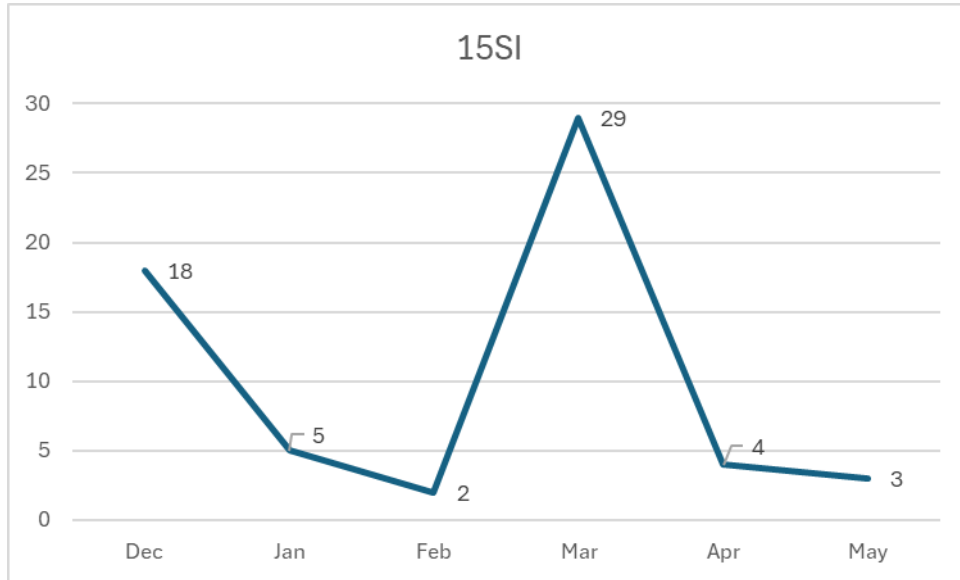
- First fluorescent with AC yoke test done in Dec25 – 18 chairs failed
- To date – 61 chairs discarded on specific chairlift

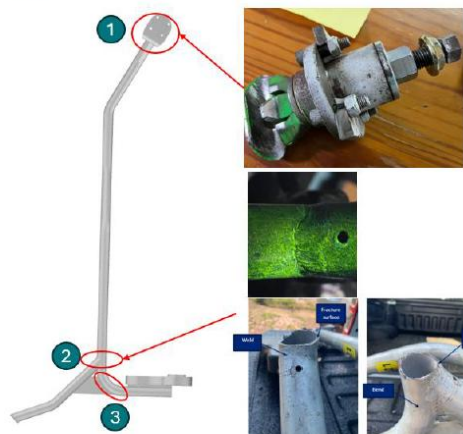
## 2.4. Legacy (Old Scharf) Chair Design

- Rope grip mounting flange:**
  - Inspect for cracks originating from bolt holes – crack originates at bolt hole and propagates to outer edge of flange
  - Inspect fillet welds between pipe and flange/support angle/gusset plates
- Footrest pipe weld**
  - Inspect for cracks originating from weld root – critical area
  - Weld propagates from weld in a transverse direction to the pipe
- Main pipe bend towards seat**
  - Inspect area for cracks originating in high stress area – crack propagates in a transverse direction to the pipe

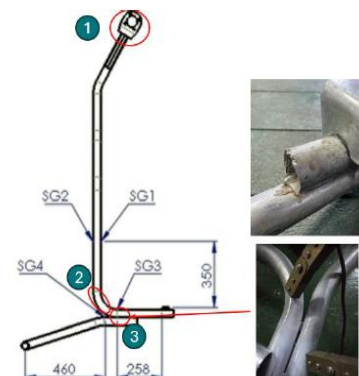
## 2.5. Hybrid Chair Design

*Figure 1: AC yoke recommended, placed across area as shown to pick up transverse crack*

- Rope grip mounting flange:**
  - Inspect for cracks originating from bolt holes – crack originates at bolt hole and propagates to outer edge of flange
  - Inspect fillet welds between pipe and flange/support angle/gusset plates
- Main pipe bend towards seat**
  - Inspect area for cracks originating in high stress area – crack propagates in a transverse direction to the pipe
- Footrest pipe weld**
  - Inspect for cracks originating from weld root – critical area – Chair to be placed on its side to inspect effectively, inspect both sides
  - Weld propagates from weld in a transverse direction to the pipe
